# Manhole Inspection Summary

Manhole # S41Y1\_005MH

Insp Date: **12/12/07 12:47 PM**

**Location** Address: **817 E. Patapsco**

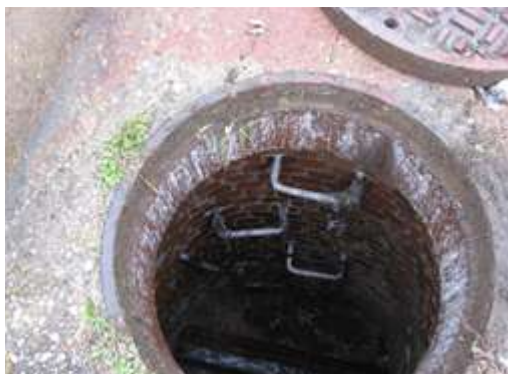
Steps

**Steps** Count: **4** Missing: **0** ☐ Corroded

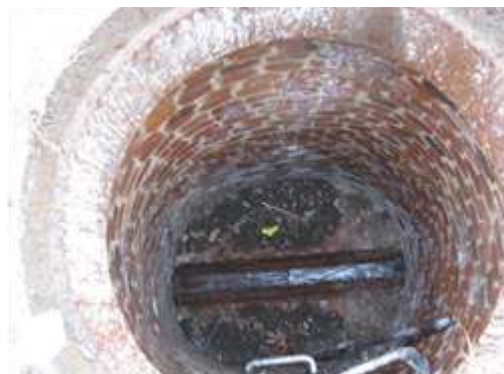
Defect 2

Bench debris

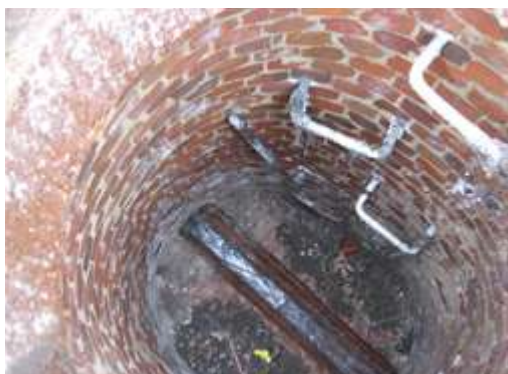
Defect 1

Bench debris

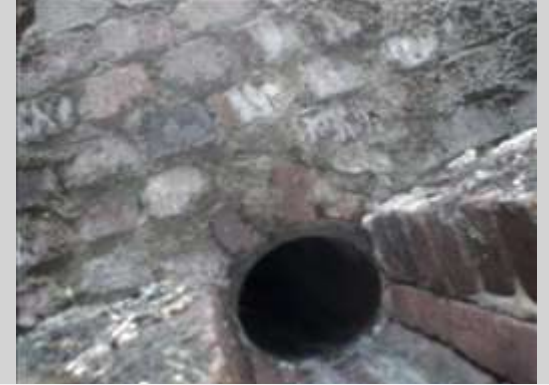
12 O'Clock Outflow

8 in. Circular Gravity Sewer  
Pipe Out @ 12 O'Clock

Pipe Height: **10.8** (in.) Rod and Bar (Angled)  
Pipe Material: **Clay** ☐ Pipe Lined  
Invert Depth: **8.48** (ft.) Flow Characteristics: **Fast**  
Deposits: ☒ None ☐ Mud ☐ Sludge ☐ Debris ☐ Grease  
Silt Depth: (in.) Deposits Extent:  
Infiltration: **None** Pipe Seal Cond: **Sound**

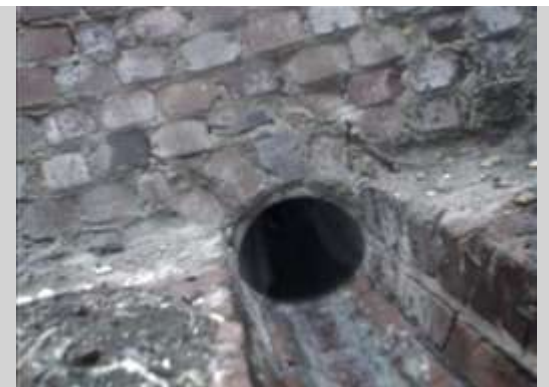
6 O'Clock Inflow

8 in. Circular Gravity Sewer  
Pipe In @ 6 O'Clock

Pipe Height: **9.6** (in.) Rod and Bar (Angled)  
Pipe Material: **Clay** ☐ Pipe Lined  
Invert Depth: **8.06** (ft.) Flow Characteristics: **Fast**  
Deposits: ☒ None ☐ Mud ☐ Sludge ☐ Debris ☐ Grease  
Silt Depth: (in.) Deposits Extent:  
Infiltration: **None** Pipe Seal Cond: **Sound**
